# CASE HISTORY

## ESP FAILURES ELIMINATED IN THE PERMIAN

DuraSet  
Precision Pump Placement

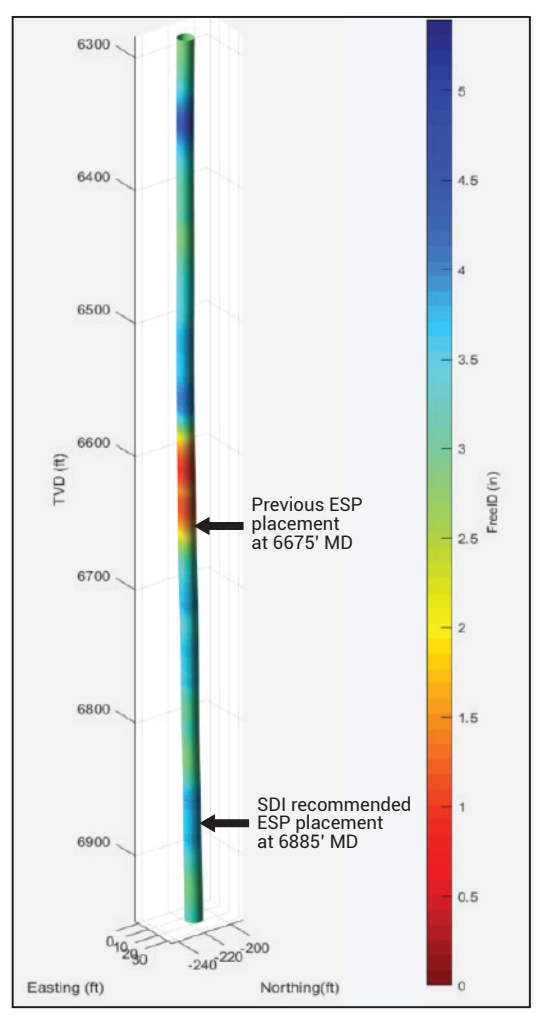
Scientific Drilling deployed the DuraSet service in order to provide a high resolution 3-D map of the wellbore. This imaging service showed that the ESP had been repeatedly set in a highly tortuous zone, which lead to premature failure due to excessive bending during operation. This zone did not appear on the original MWD survey listing, as the long survey interval masked localized doglegs. The customer then used the proprietary DuraSet FREEID log to evaluate the tortuosity of the wellbore against the specific combination of ESP and casing size.

Armed with a better understanding of the wellbore's tortuosity, a replacement ESP was installed at an optimal depth in the wellbore where bending was minimized, and ESP fatigue would be reduced. The well has now been online for nine months without another ESP issue, thus significantly increasing the well's ROI for the customer.
