# CASE HISTORY

## DuraSet WELLBORE RESTRICTION ANALYSIS

Completions, Wellbore Positioning Services, Cased Hole Services, High Dogleg Severity, Wellbore Restriction Determination

Texas Panhandle

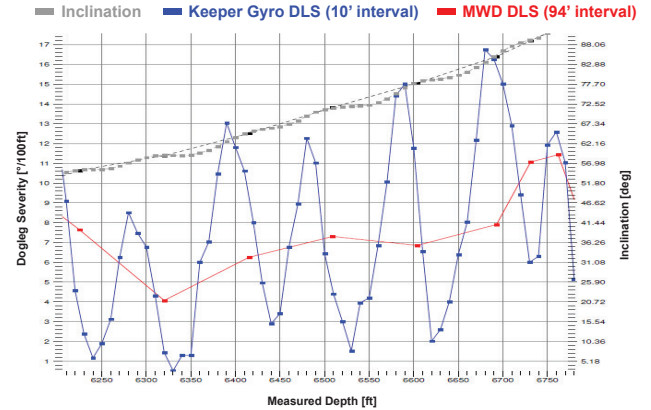
Figure 1: High Resolution Dog Leg Severity VS Measured Depth

The DuraSet Analysis, performed at SDI's remote data center, showed significant tortuosity and highly inconsistent dogleg severity throughout the curve portion of the wellbore (see figure 1).

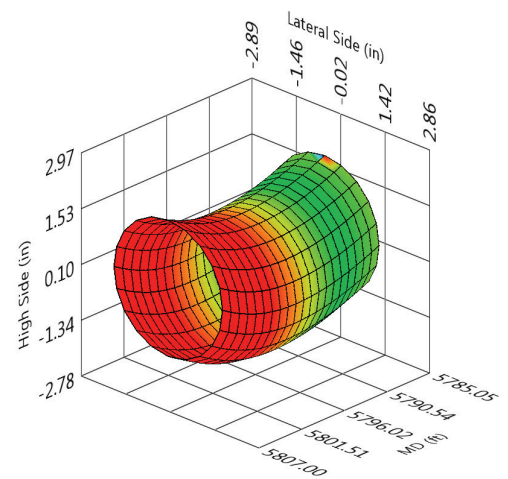
Figure 2: Free ID 3-D Visualization

It was determined that the wellbore casing's minimum effective diameter was smaller than the OD of the plug based on the length of the assembly (see figure 2, 3-D visualization). The caliper data confirmed no casing deformation had occurred while also enabling the DuraSet's Free Internal Diameter (ID) Analysis to be calculated with respect to the wellbores true ID instead of an assumed nominal diameter.

Using this data the customer was able to modify the length of the assembly based on the SDI recommended maximum length. Operations recommenced and were completed without another premature plug setting incident.
