CASE HISTORY

DuraSet WELLBORE RESTRICTION ANALYSIS

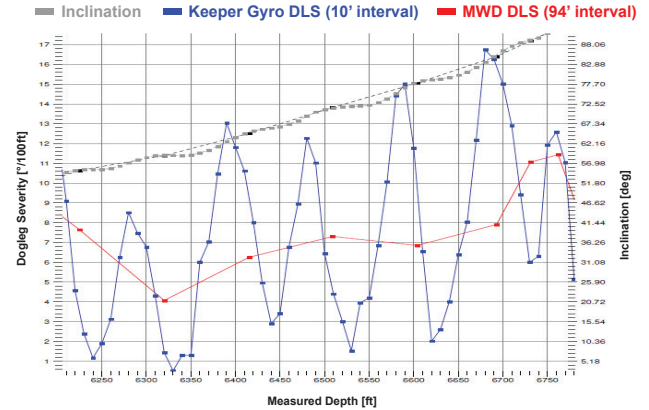
The DuraSet Analysis, performed at SDI's remote data center, showed significant tortuosity and highly inconsistent dogleg severity throughout the curve portion of the wellbore (see figure 1).

Figure 1: High Resolution Dog Leg Severity VS Measured Depth
