CASE HISTORY

DuraSet WELLBORE RESTRICTION ANALYSIS

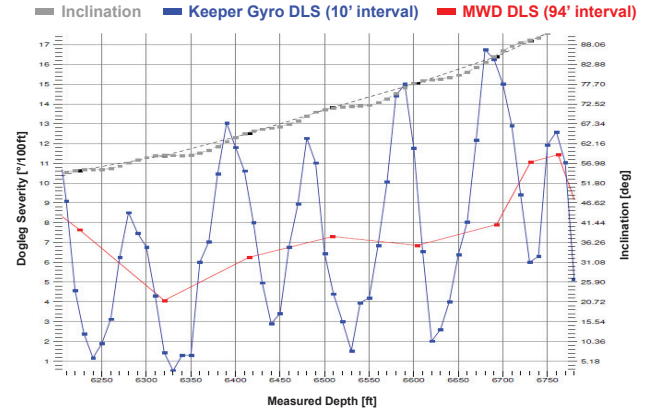
Figure 1: High Resolution Dog Leg Severity VS Measured Depth

The DuraSet Analysis, performed at SDI's remote data center, showed significant tortuosity and highly inconsistent dogleg severity throughout the curve portion of the wellbore (see figure 1).

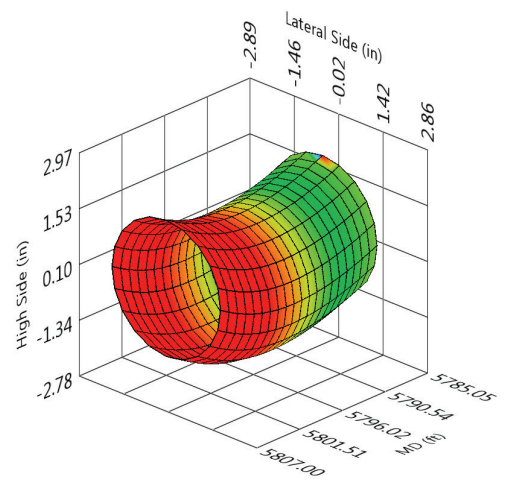
Figure 2: Free ID 3-D Visualization

It was determined that the wellbore casing's minimum effective diameter was smaller than the OD of the plug based on the length of the assembly (see figure 2, 3-D visualization). The caliper data confirmed no casing deformation had occurred while also enabling the DuraSet's Free Internal Diameter (ID) Analysis to be calculated with respect to the wellbores true ID instead of an assumed nominal diameter.
