CASE HISTORY

THERMAL EOR WELL INTEGRITY EVALUATION

Oil Sands,
Canada

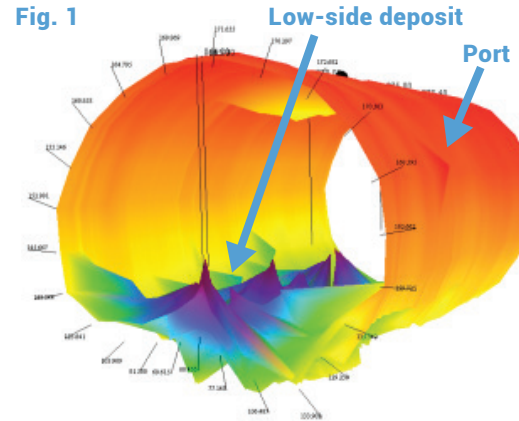
The processed data revealed several anomalies including deposition (figure 1), buckling (figure 2), and flow control ports were also successfully identified (figure 3).

The data and images provided the operator with an understanding of the condition of the wellbore that enabled subsequent remedial well interventions to be planned with accuracy, reducing risk whilst saving time and money.

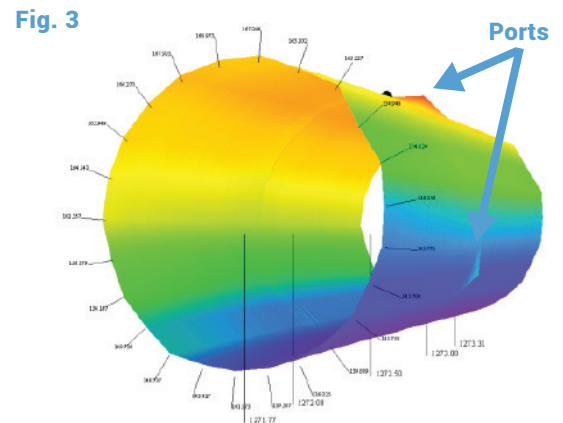
Because of the high deviation, the mode of deployment would be coiled tubing. Another major challenge was an anticipated downhole temperature in the region of 200°C. In addition, each FCD Joint had 4 perforated holes 90° apart, and the operator wanted to verify corrosion over each joint with a high-resolution Caliper.
