CASE HISTORY

Vulcan™ MFT-40 DISCOVERS INADVERTENT SIDETRACK

Cased Hole Services
Geothermal
Well Integrity

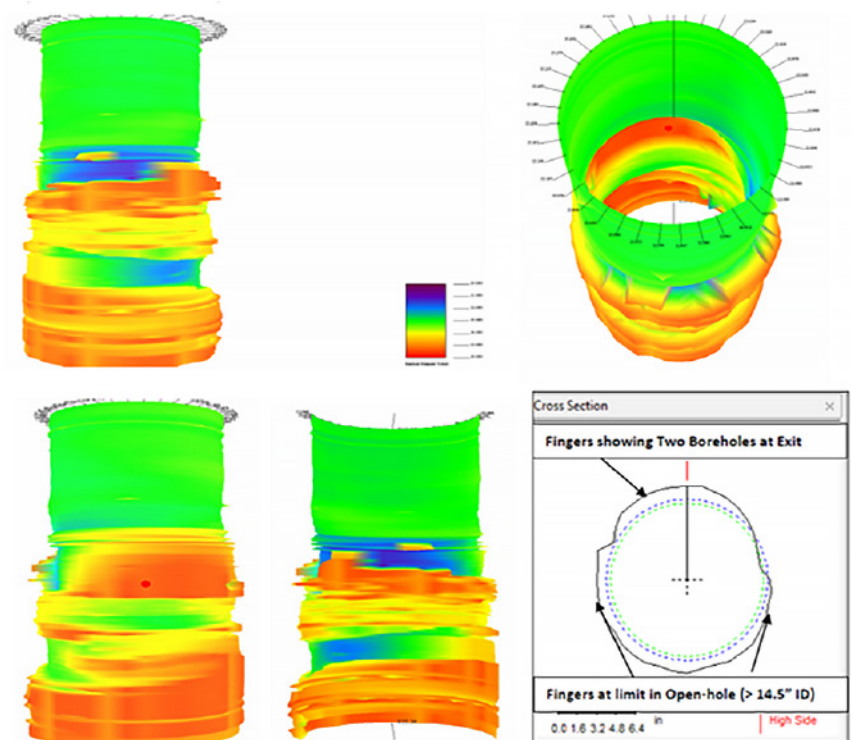
Scientific Drilling's Vulcan™ MFT-40 multi-finger geothermal caliper was chosen to survey the well and confirm the status of the 13-3/8" casing. Upon processing the caliper data, the log analyst soon realised a major anomaly had been detected by the caliper. The cross sectional diagram shows that two boreholes were detected, one cased hole the other openhole. This signified an inadvertent sidetrack. The 3D images clearly depict the contrast between the cased hole and open hole as the caliper fingers reach their measurement limit of 14.5".

By utilizing SDI's Vulcan™ MFT-40 caliper, the operator gained crucial insight into the status of its well. With this information, a tailored remedial program was implemented to regain well integrity.
